New Hampshire Volunteer Lake Assessment Program

2003 Biennial Report for Webster Lake Franklin

NHDES Water Division Watershed Management Bureau 29 Hazen Drive Concord, NH 03301

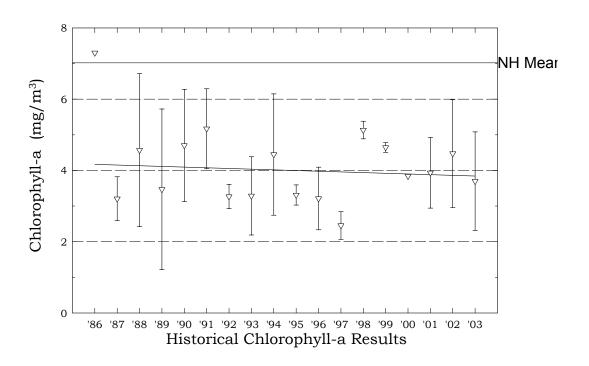
Figure 1. Monthly and Historical Chlorophyll-a Results

Figure 1 and Table 1: The graphs in Figure 1 (Appendix A) show the historical and current year chlorophyll-a concentration in the water column. Table 1 (Appendix B) lists the maximum, minimum, and mean concentration for each sampling season that the lake has been monitored through the program.

The current year data (the top graph) show that the chlorophyll-a concentration *increased* from May to June, *decreased* from June through August, and then *increased* from August to September. The chlorophyll-a concentration in all months was *less than* the state mean.

The historical data (the bottom graph) show that the 2003 chlorophyll-a mean was *less than* the state mean.

Overall, the statistical analysis of the historical data (the bottom graph) shows that the mean annual chlorophyll-a concentration has **not significantly changed** (neither *increased* nor *decreased*) since monitoring began in 1986. Specifically, the chlorophyll-a concentration has remained **relatively stable** and has been **less than** the state median. (Note: Please refer to Appendix E for the detailed statistical analysis explanation and data print out.)

While algae are naturally present in all lakes/ponds, an excessive or increasing amount of any type is not welcomed. In freshwater lakes/ponds, phosphorus is the nutrient that algae depend upon for growth. Algal concentrations may increase with an increase in nonpoint sources of phosphorus loading from the watershed, or inlake sources of phosphorus loading (such as phosphorus releases from the sediments). Therefore, it is extremely important for volunteer monitors to continually educate residents about how activities within the watershed can affect phosphorus loading and lake/pond quality.

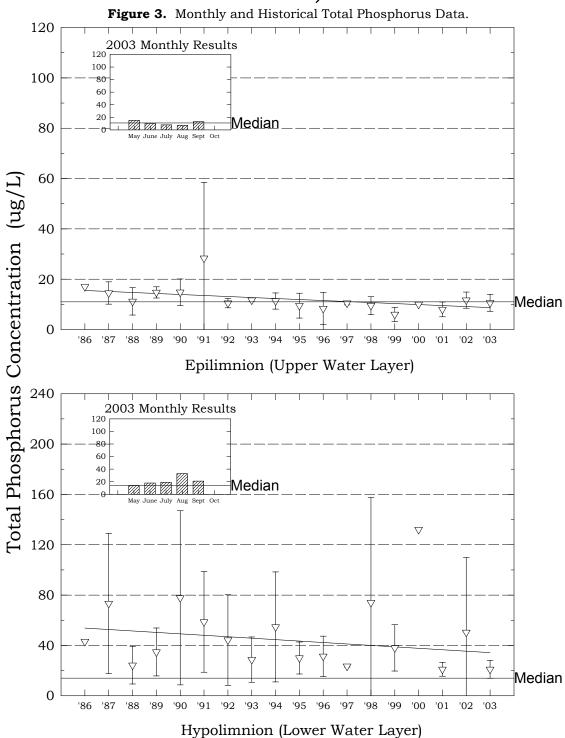
Figure 3 and Table 8: The graphs in Figure 3 (Appendix A) show the amounts of phosphorus in the epilimnion (the upper layer) and the hypolimnion (the lower layer); the inset graphs show current year data. Table 8 (Appendix B) lists the annual maximum, minimum, and median concentration for each deep spot layer and each tributary since the lake joined the program.

The current year data for the epilimnion (the top inset graph) show that the phosphorus concentration **decreased** from May through August, and then **increased** in September. The phosphorus concentration in June, July, and August was **less than** the state median, while in May and September the concentration was **greater than** the state median.

The historical data show that the 2003 mean epilimnetic phosphorus concentration is **approximately equal to** the state median.

The current year data for the hypolimnion (the bottom inset graph) show that the phosphorus concentration *increased* from May through August, and then *decreased* in September. The phosphorus concentration in May was *less than* the state median, while in June, July, August, and September the concentration was *greater than* the state median.

The historical data show that the 2003 mean hypolimnetic phosphorus concentration is *greater than* the state median.

Overall, the statistical analysis of the historical data show that the phosphorus concentration in the hypolimnion (lower layer) has **not significantly changed** (neither *increased* nor *decreased*) since monitoring began in 1986. Specifically, the phosphorus concentration in the hypolimnion has remained **relatively stable** and has been **greater than** the state median. (Note: Please refer to Appendix E for the statistical analysis explanation and data print out.)

Overall, the statistical analysis of the historical data show that the phosphorus concentration in the epilimnion (upper layer) has **significantly decreased** since monitoring began. Specifically, the phosphorus concentration in the epilimnion has **decreased** (meaning **improved**) on average by **approximately ten percent** per sampling

season during the sampling period **1986** to **2003**. (Note: Please refer to Appendix E for the statistical analysis explanation and data print out.) We hope this trend continues!

One of the most important approaches to reducing phosphorus loading to a waterbody is to continually educate watershed residents about its sources and how excessive amounts can adversely impact the ecology and value of lakes and ponds. Phosphorus sources within a lake or pond's watershed typically include septic systems, animal waste, lawn fertilizer, road and construction erosion, and natural wetlands.
